AmericanLifelinesAlliance

Flood Resistant Local Road Systems

Appendix B: Allegany County, MD

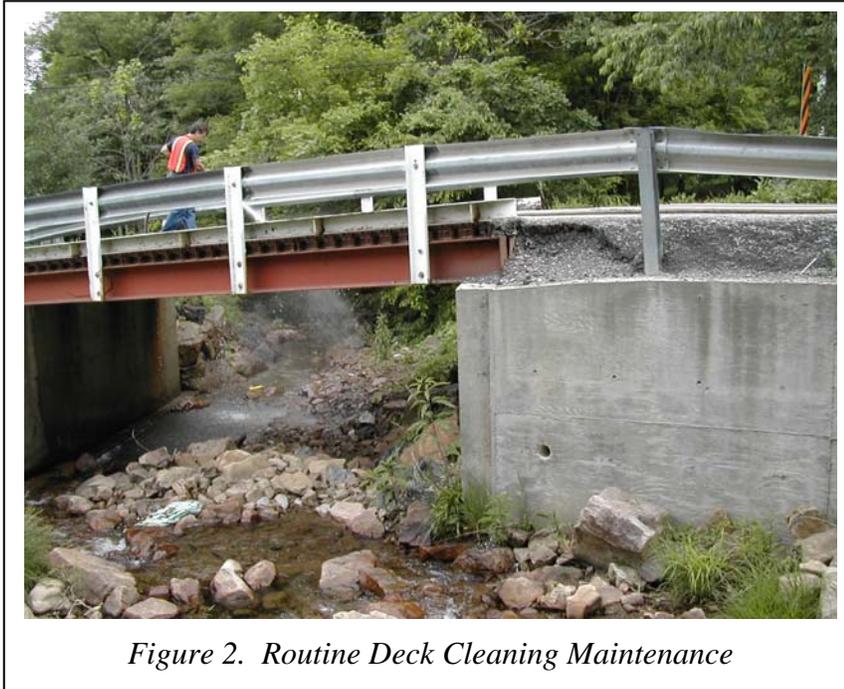
Figure 2. Routine Deck Cleaning Maintenance

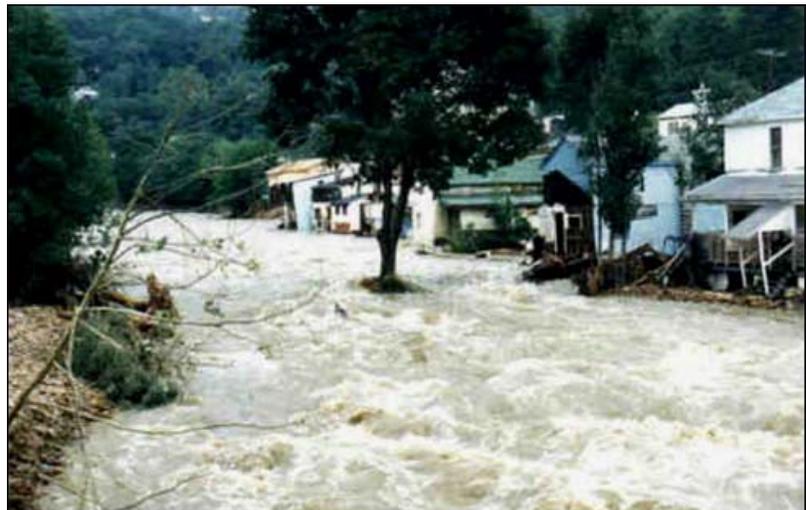
Figure 3. Georges Creek in the Town of Westernport (September 1996).

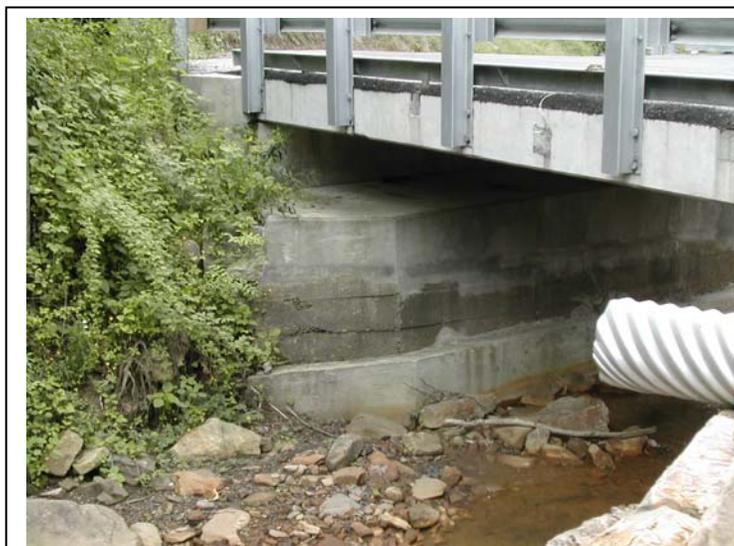
Figure 9. Sugar Maple Road New South Abutment (looking downstream)

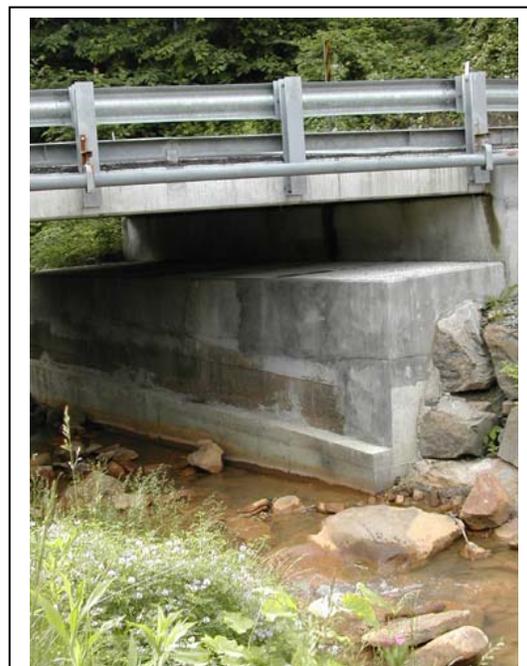
Figure 11. Sugar Maple Road New South Abutment (looking upstream)

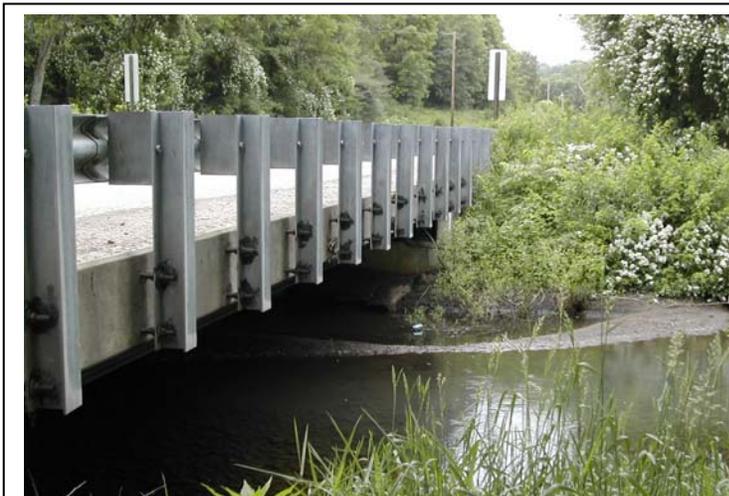
The gradient of the streambed is fairly flat in this reach. With a total span of 53 feet, the Klondike Road bridge does not alter the natural channel width and flows are not concentrated. The bridge itself presents minimal obstruction to the passage of floodwaters because the approaches are essentially at-grade and perpendicular to the stream, the abutments are keyed into bedrock, and the bridge deck is shallow. No utilities are mounted on the bridge. While some minor debris removal has been required, accumulation of debris and blockage of flows has not been a problem.

Figure 13. Klondike Road Bridge (upstream).

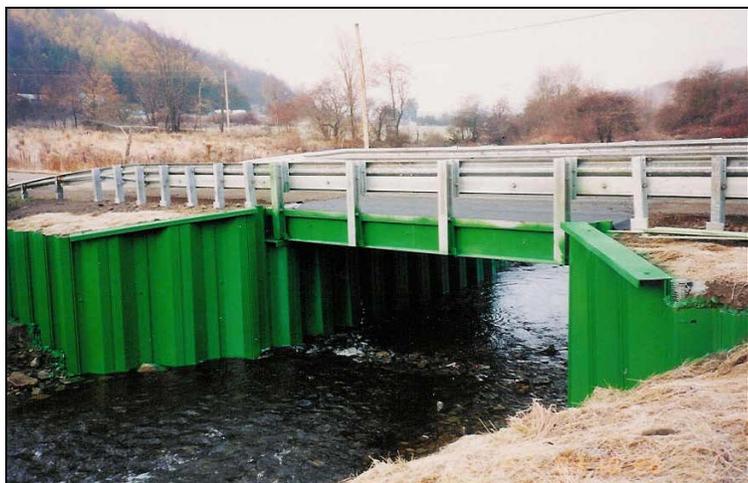
Bridges/Culverts – Configurations. Allegany County does not have formalized local requirements applicable to bridges and culverts with less than 20-foot span (i.e., those that do not satisfy the federal definition). For in-house design work the DPW follows NYSDOT guidelines and generic abutment and superstructure drawings, with minor tailoring for site-specific conditions. This approach is taken for consistency and to minimize liability, because the generic drawings were prepared by experienced and qualified authorities. The County is self-insured; consistently applying the same standard to all projects is an effective way to minimize liability in the event of an incident that might be attributed to the physical configuration or condition of the local road system.

Figure 5. Typical small bridge built by County's crew

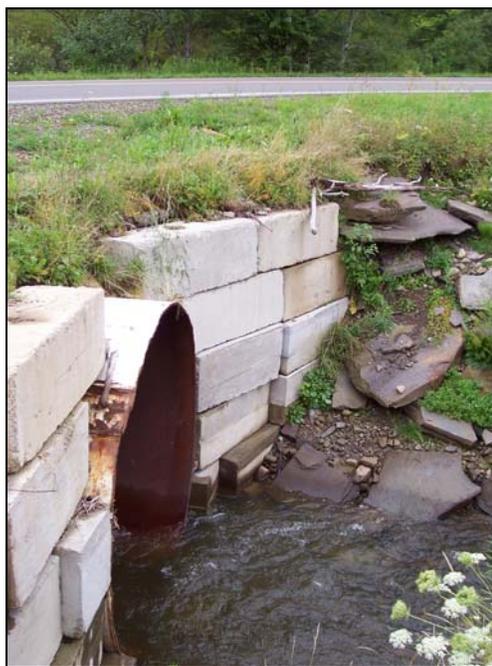
DPW usually keeps a number of recycled railroad tank cars (8- and 10-foot diameter, ends removed) on hand to use when a temporary crossing is needed or an emergency situation arises. On very low volume roads sometimes these installations become more or less permanent, with concrete block endwall treatment. Although they may be more susceptible to flood damage, they are low-cost and easy to replace if damaged before funds are available to install permanent headwalls (Figure 6).

Figure 6. Temporary headwalls at railroad tank culvert

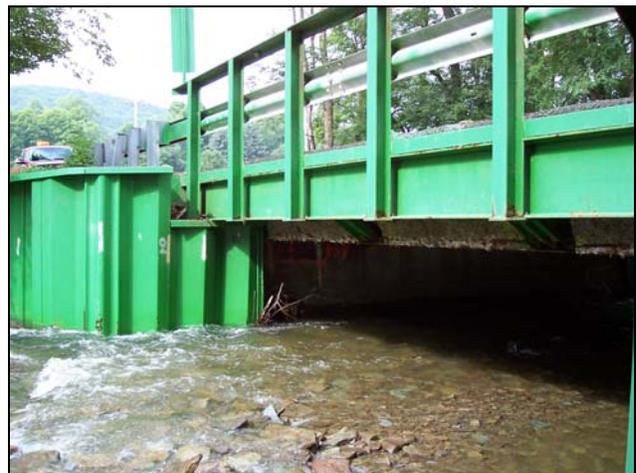
Cost also becomes a factor if a larger structure is called for in order to pass the desired discharge. When considering replacement of circular pipes, if the assessment indicates that a larger pipe size does not provide adequate functioning, then a bridge or box culvert structure is evaluated. Sometimes costs preclude significantly improving hydraulics, although usually some improvement can be provided by improving the headwall (Figure 7).

Figure 7. Sheetpiling improves inlet conditions

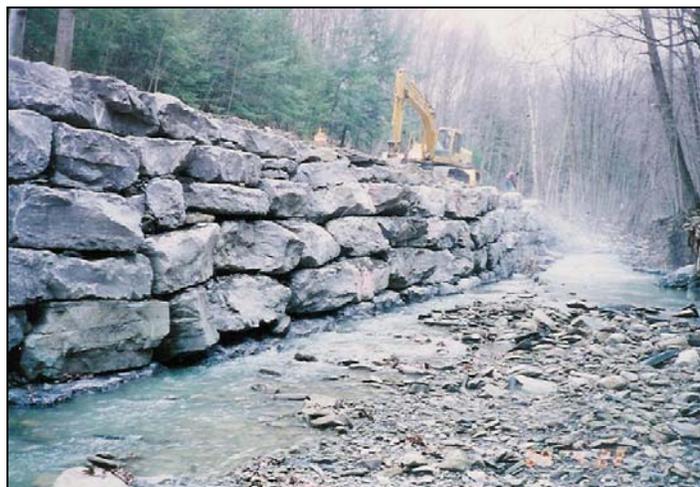
In a number of locations, large quarried blocks of stone are placed to protect eroding stream banks (Figure 8). When the slope is steep, the blocks are pinned to bedrock and to each other; where slopes allow, the blocks are not pinned. Similar installations have been in place for about 25 years and have proven effective. Scour analyses are not prepared to pick the stone size. The County has a number of road crossings where old laid-up stone walls still provide some stream bank protection. When washed out by floodwaters they are replaced with stone blocks (which are lower cost than FEMA's cost code for replacement of laid-up stone).

Figure 8. Stone stream bank protection

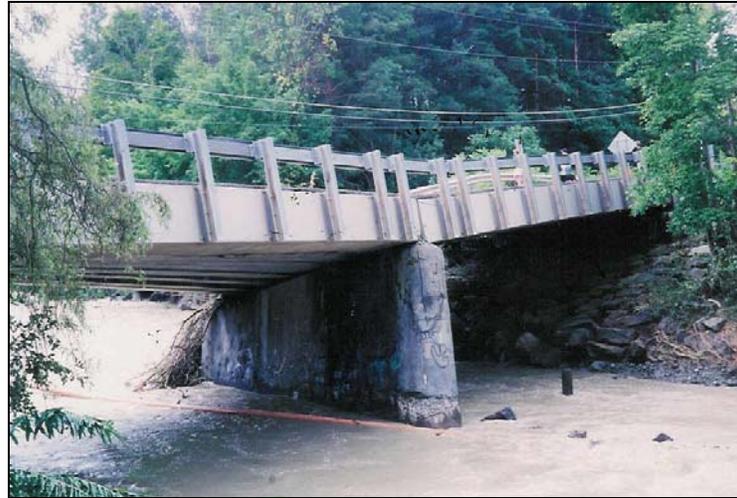
Figure 9. Damaged County Route 1 Bridge over Van Campen Creek.

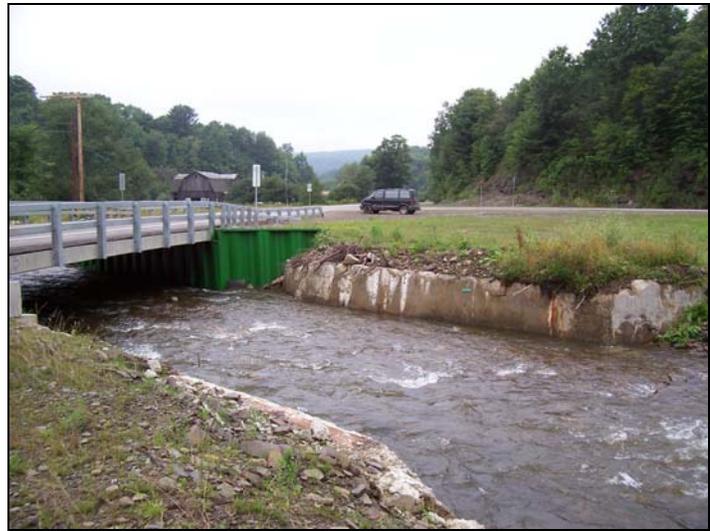
Following the County's standard practice, the replacement bridge opening was selected to improve conveyance of flood flows. The new bridge is the same width as the old bridge and approximately 2 feet higher (for a total of about five feet above normal water surface). This configuration was selected after an in-house determination of the discharge for the 100-year flood (using methods described in Section 2.3).

Figure 10. New County Route 19 bridge over Spring Mills Creek

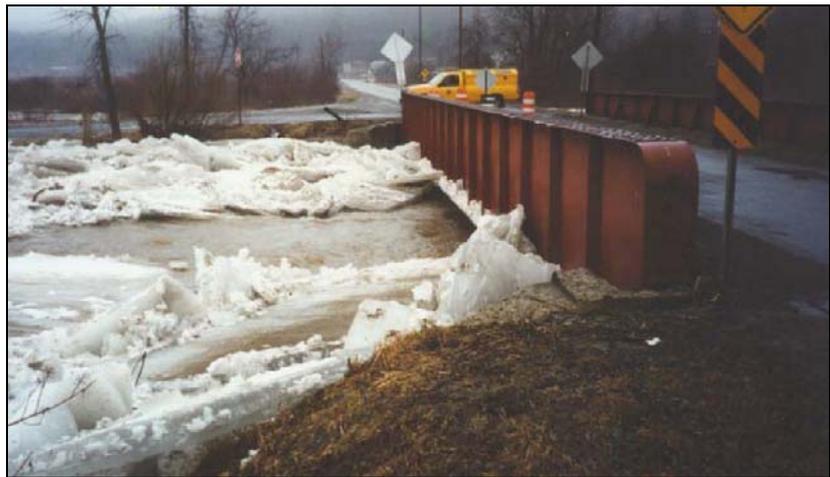
The old bridge was subject to nearly annual flooding, including ice-jamming in the winter (Figure 11). With low approach roads and the bottom of the 80-foot clear span girders barely 3 feet above normal water level, access was severely restricted during high water. The road was closed frequently, not only when water covered the road, but also when water

Figure 11. Ice jamming at the old York's Corner bridge

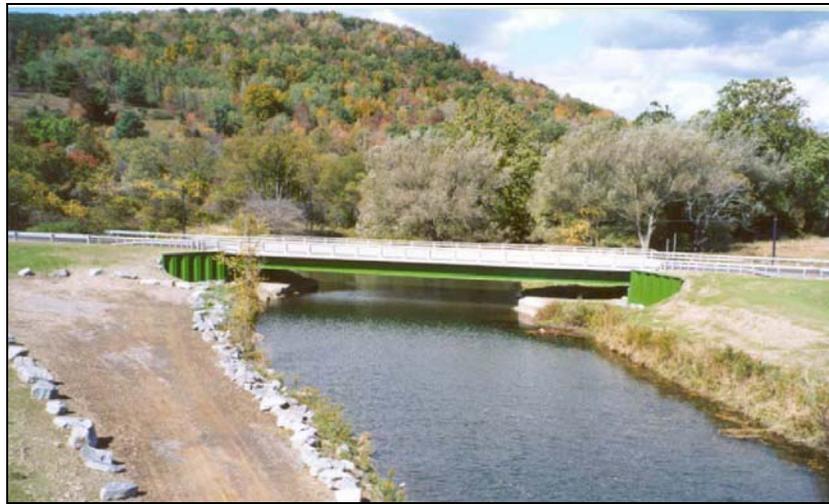
To improve hydraulic performance, new abutments were constructed both higher and set back from the old abutments, which were left in place both for scour protection and to concentrate low flows for fish passage (Figure 12).

Figure 12. New York’s Corner bridge

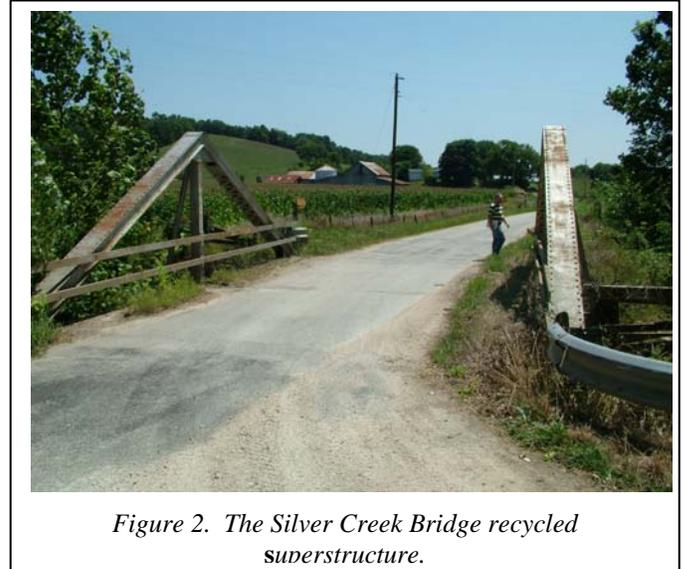
Figure 2. The Silver Creek Bridge recycled superstructure.

Therefore, the URD waits until a bridge has a Sufficiency Rating that prompts replacement before initiating a remedy. Figure 2 and Figure 3 show the Silver Creek Bridge. With a Sufficiency Rating less than 50, this structure has been in the queue for replacement since 1999.

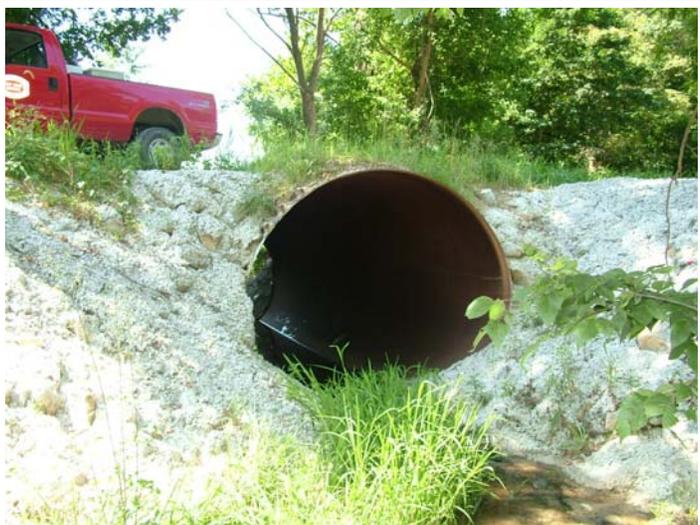
The damaged box culvert was one of the old culverts that the County Engineer planned to replace with a recycled steel railroad tank car. In this case, the new culvert is 8' in diameter with grouted riprap at both ends to protect against erosion in case of future overtopping (Figure 4 and Figure 5). It met the State requirement that a replacement culvert must provide at least the same amount of effective waterway opening as the pre-existing structure.

Figure 4. New culvert on Hoot Owl Hollow Road –downstream.

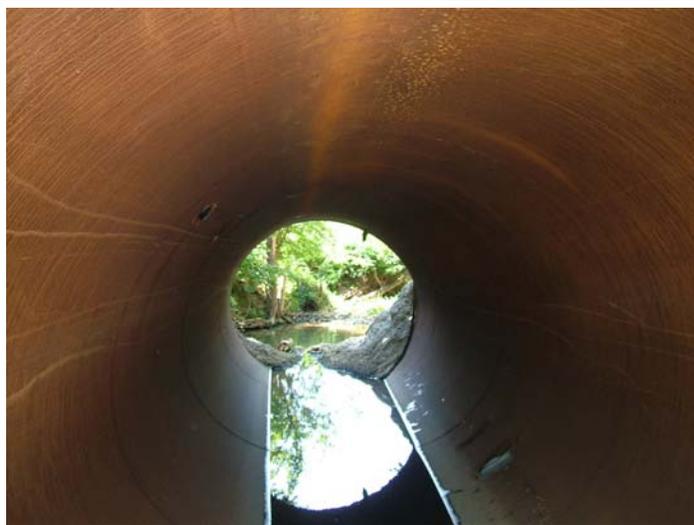
Figure 5. New culvert on Hoot Owl Hollow Road – interior.

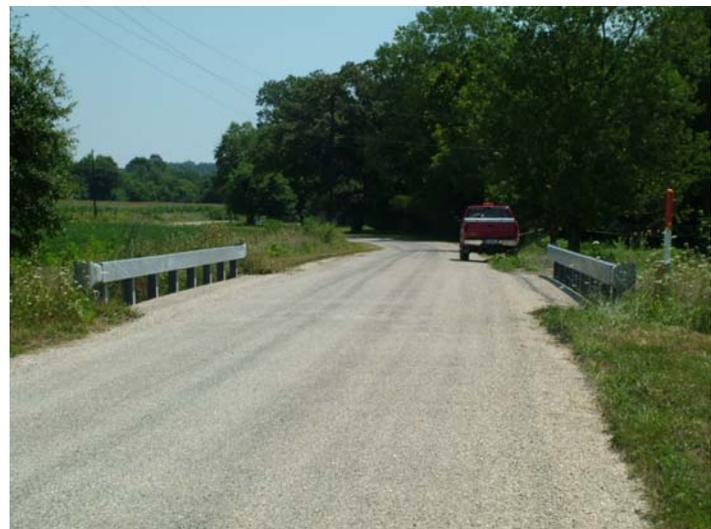
Figure 9. New Belleview Hollow Road Bridge – widened road and shoulders.

Although engineering plans were drawn up in 1994, construction by URD's crew started in October 1998 and took seven months. Funding came from Federal Bridge Repair funds and the total cost was about \$102,000. The bridge has a superstructure of precast, prestressed concrete deck beams and closed concrete abutments with sheetpiling inlet and outlet protection (Figure 7 and Figure 8). Changes from the old structure were that the surface width was widened slightly and the shoulder to shoulder width was increased from 22' to 24' thereby permitting the safe use of bridge rails (Figure 9).

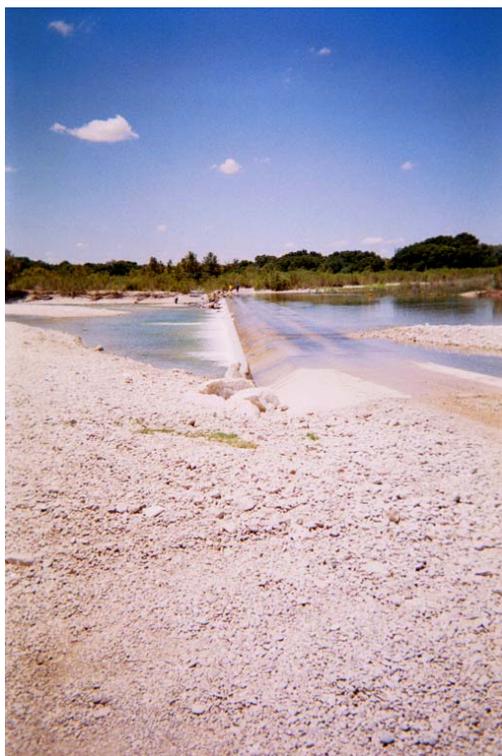
Figure 4. Typical concrete slab low water crossing (without pipes).

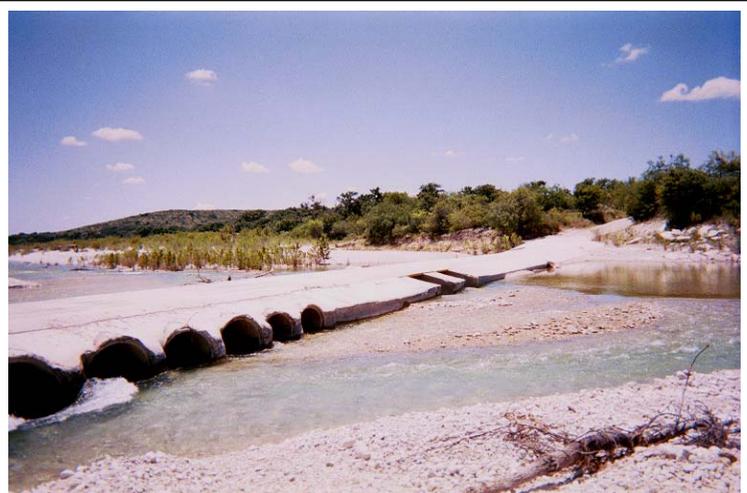
are higher and it is important to provide some access even during relatively moderate flows, the slab crossings are raised with multiple corrugated metal pipes to carry flow (Figure 5). These structures are low profile and intended to overtop during high water events. The Road Department has constructed eight slab crossings since 1992.

Figure 5. Typical concrete slab crossing (with pipes).

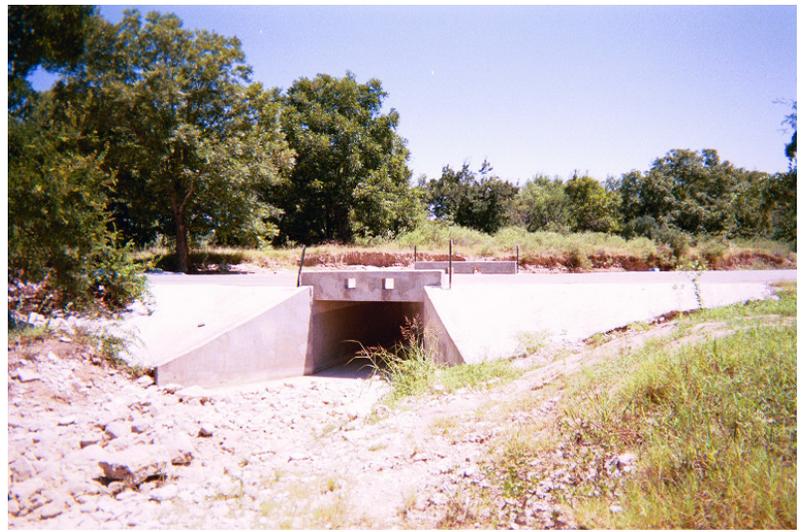
Single or multiple cell box culverts. These crossings are low profile structures that are intended carry relatively moderate rises in flows without interrupting traffic, yet will overtop by high water (Figure 6). Because they are installed where they can be keyed into bedrock, significant scour is not problematic, although minor scour occurs where the structure ties into the approach road. Three box culvert crossings have been built by the County since 1992. There is no documentation regarding design decisions on the other four.

Figure 6. Box culvert built by Uvalde County.

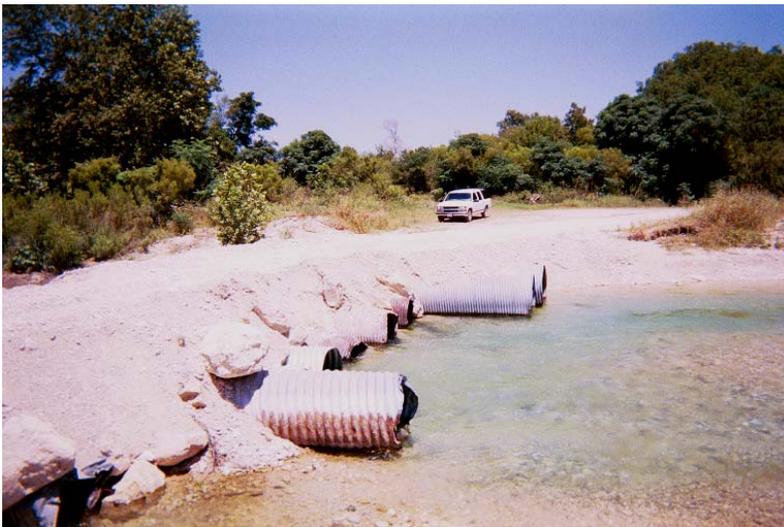
Caliche crossings. Caliche crossings are used at six locations: five on the Nueces River and one on Bear Creek (Figure 7). These crossings provide access and serviceability for moderate traffic volumes and where other types of crossings are not feasible because the lack of foundation/bedrock precludes construction of concrete slab crossings or box culverts. For example, investigations at County Road 414 over the Nueces River revealed nearly 40-foot thick gravel deposits over bedrock. The crossings are composed of multiple corrugated metal pipes laid in the streambed, typically to one side of the main channel, with local gravel deposits pushed over the pipes. The driving surface is created by spreading crushed limestone gravel (caliche) that is then graded and rolled. By their very nature, caliche crossings are prone to washout, but also are easy to restore.

Figure 7. Caliche crossing for County Road 414 over the Nueces River.

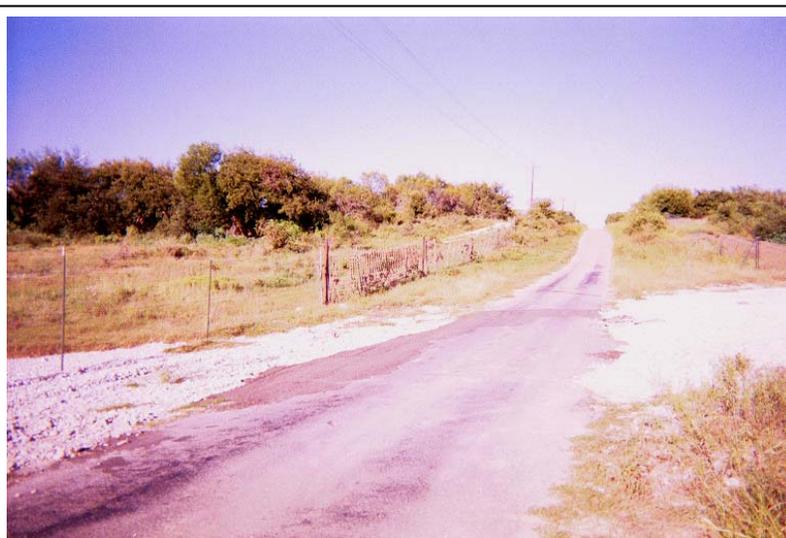
Figure 8. Typical dip in unpaved road, showing washout path (from left to right).

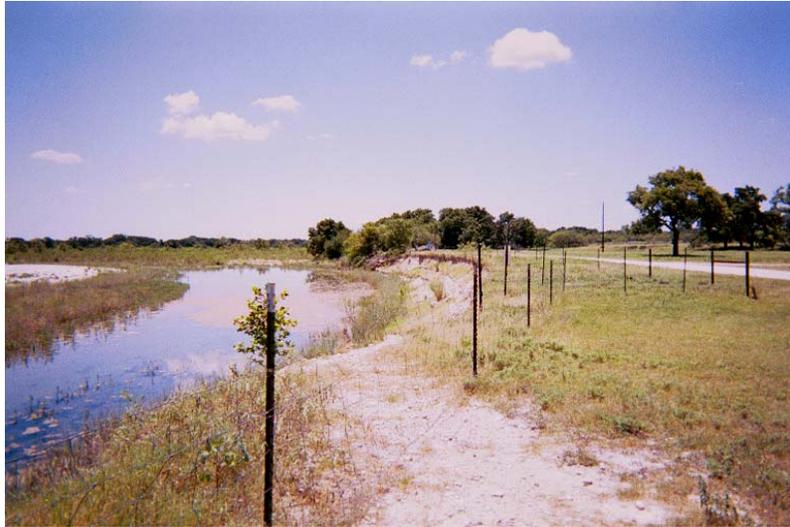
Figure 9. High bank erosion threatens relocated unpaved road (to right).

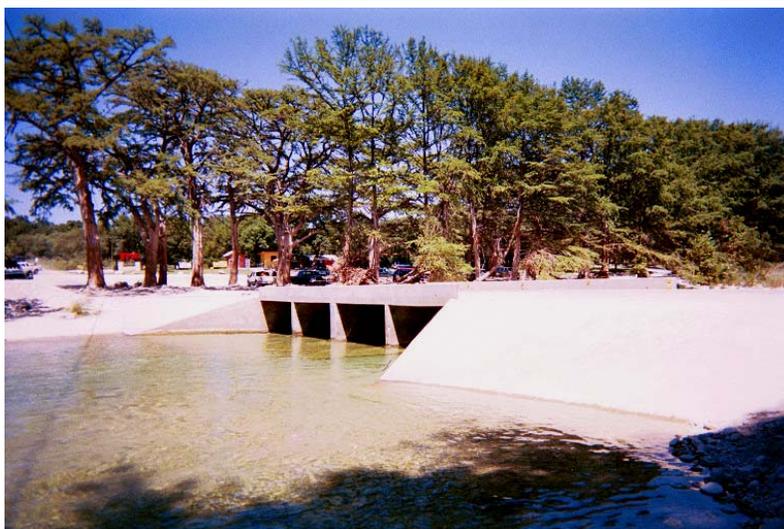
Figure 10. Typical box culvert built by Uvalde County, County Road 348 over the Frio River.

The crossing consists of four boxes each measuring 9-feet wide and 5-feet high (Figure 10). The structural design was based on the generic structural design provided by the San Antonio District

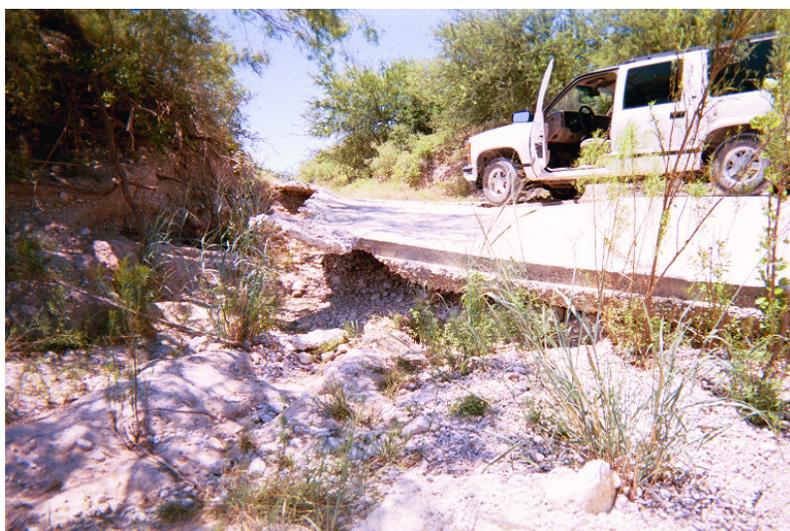
Figure 11. Scour at transition of approach road and crossing.

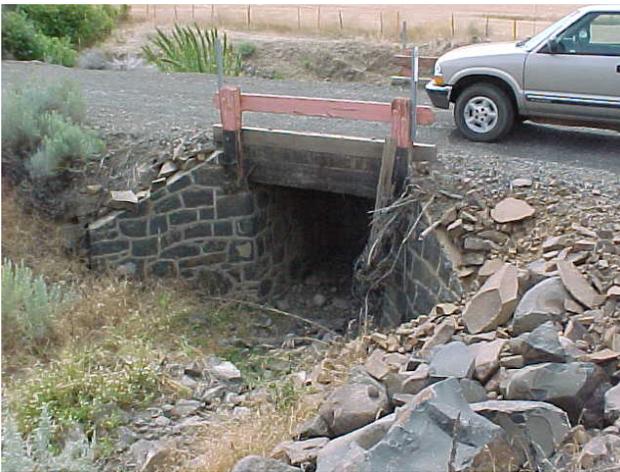
Figure 2. Inlet of Typical Short Span Bridge

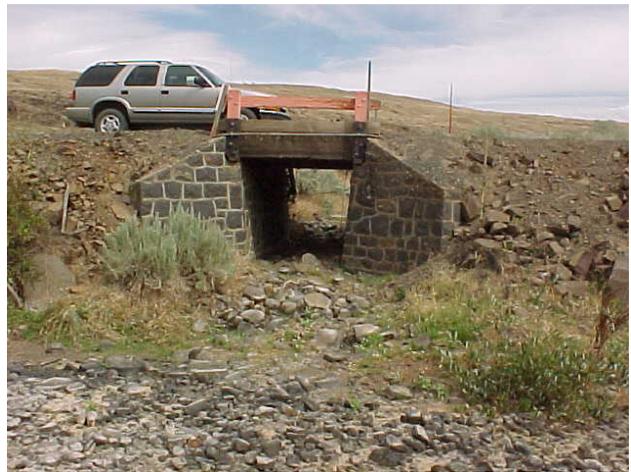
Figure 3. Outlet of Typical Short Span Bridge

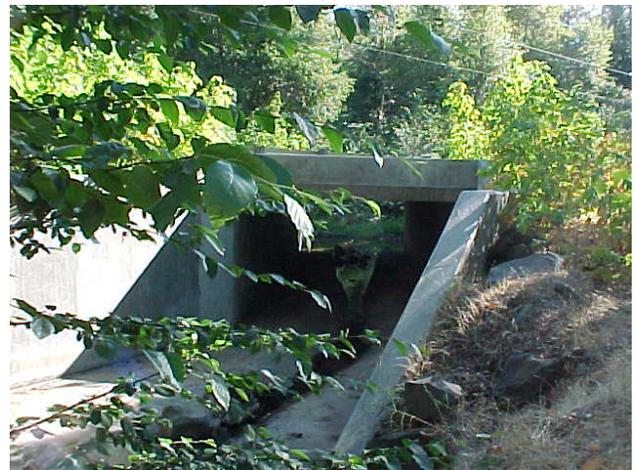
Figure 4. Inlet of Box Culvert, with Fish Passage Channel
